UNITED STATES ENVIRONMENTAL PROTECTION AGENCY
REGION 10
1200 Sixth Avenue, Suite 900
Seattle, WA 98101-3140

Re: Source of Release(s) Impacting Monitoring Well A-34
Nu-West Industries, Soda Springs, Idaho
Idaho Facility, EPA ID #: IDD 000 466 888

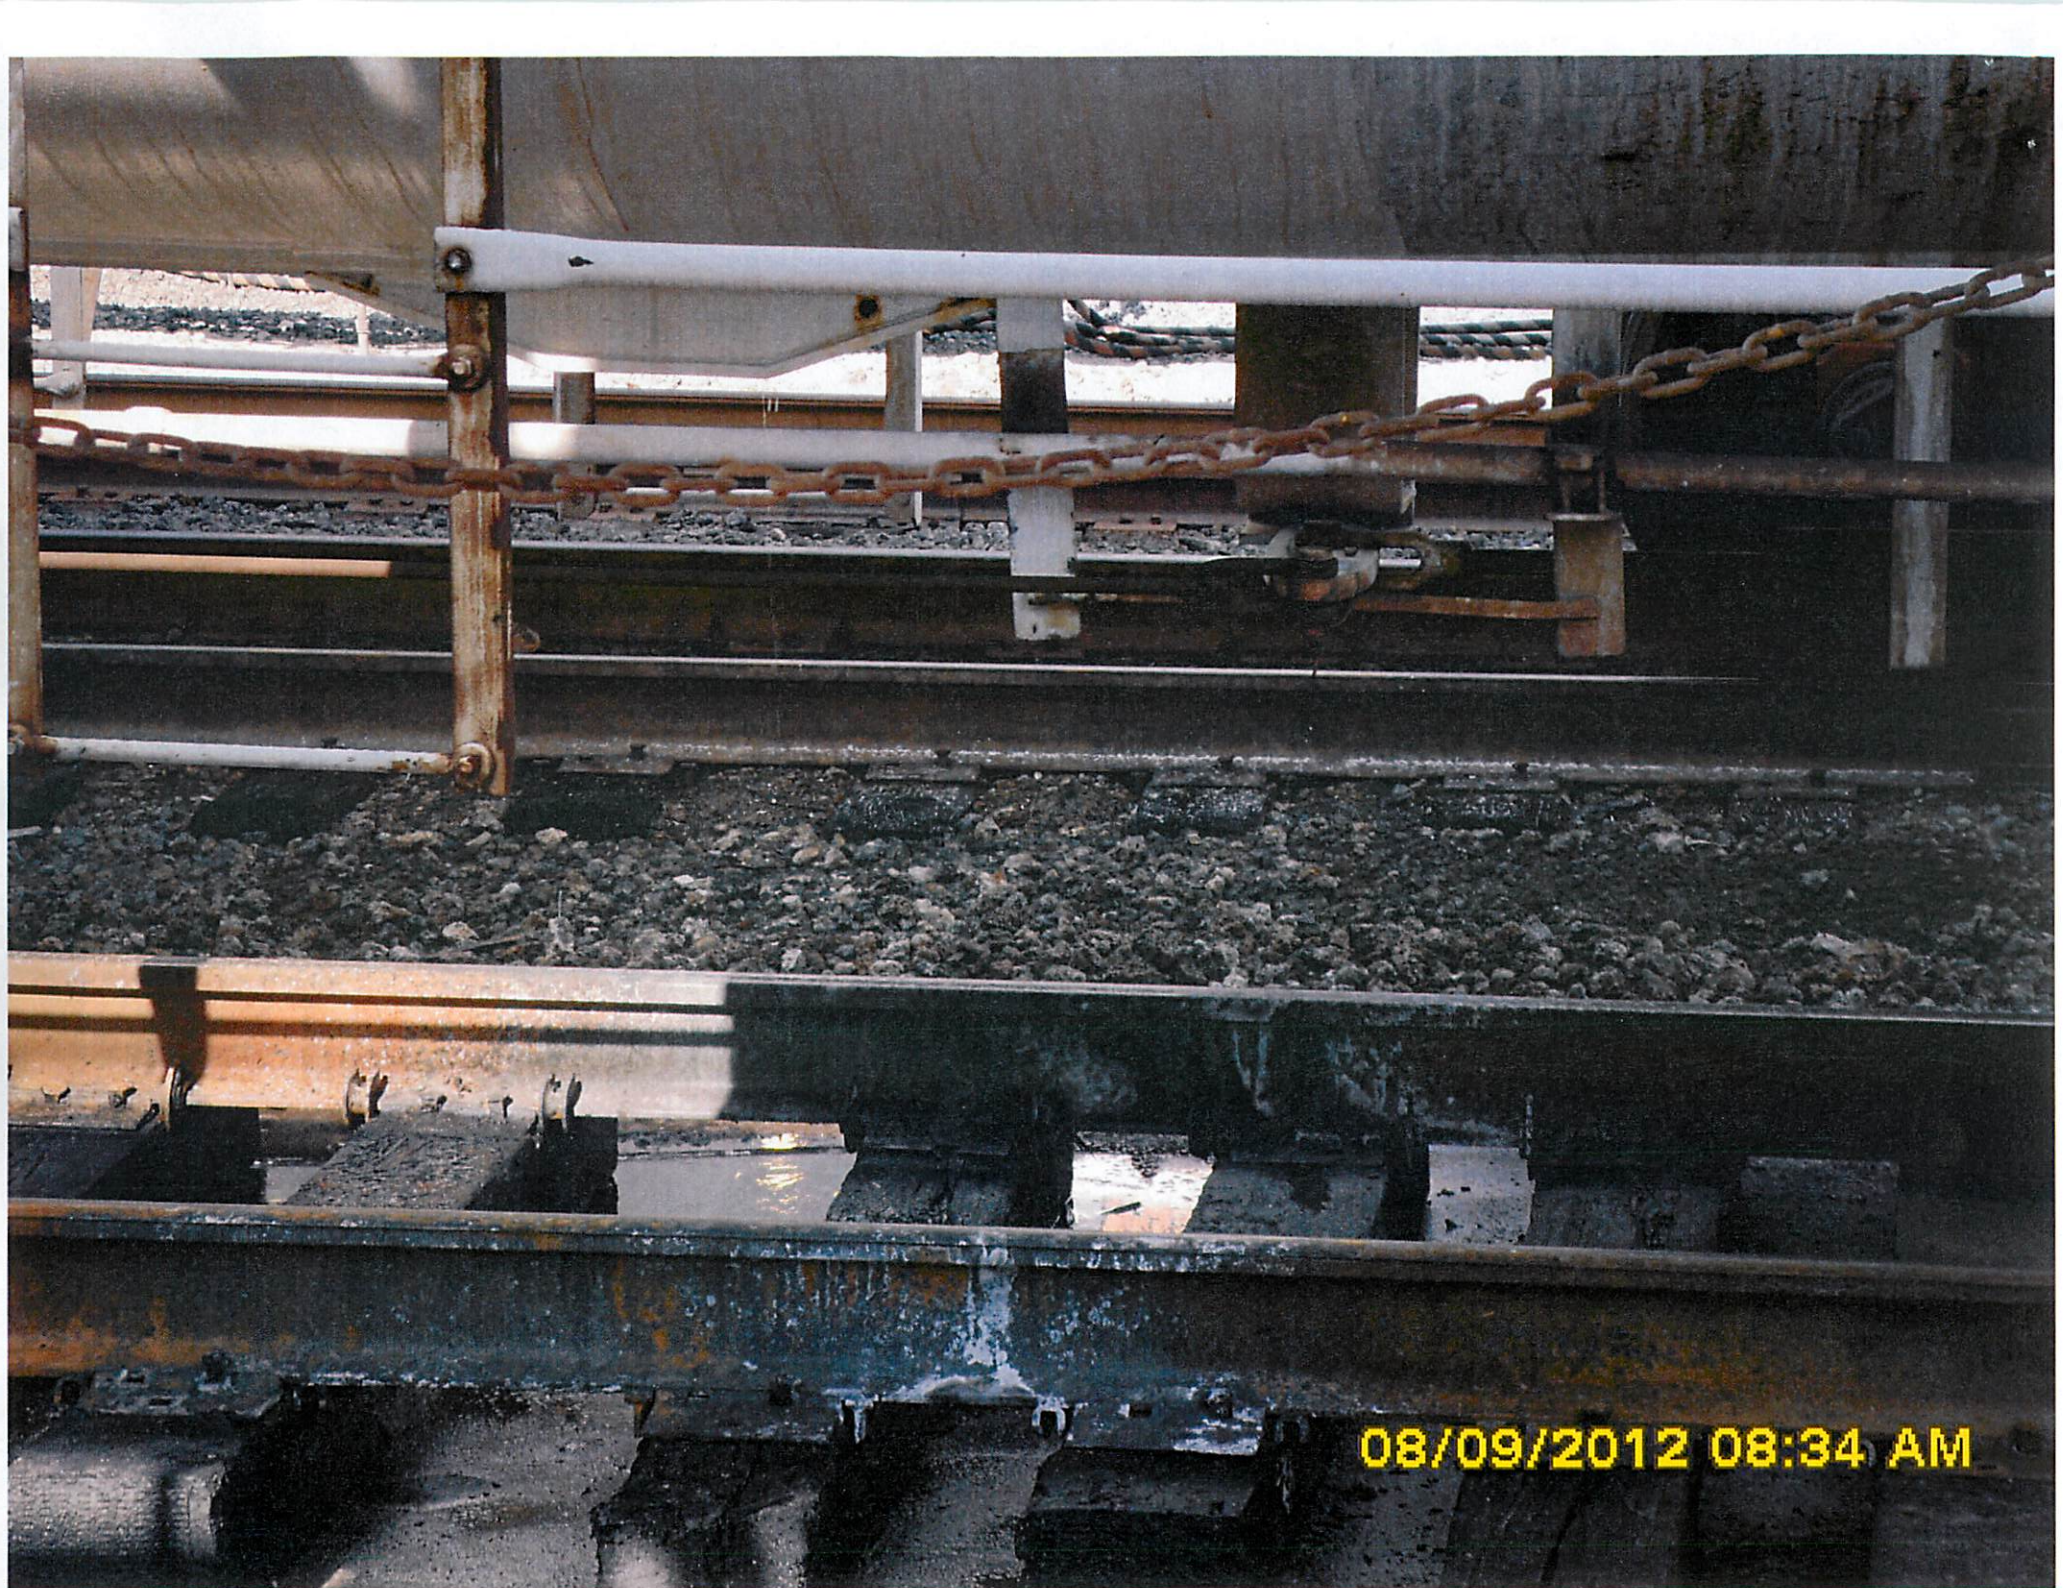
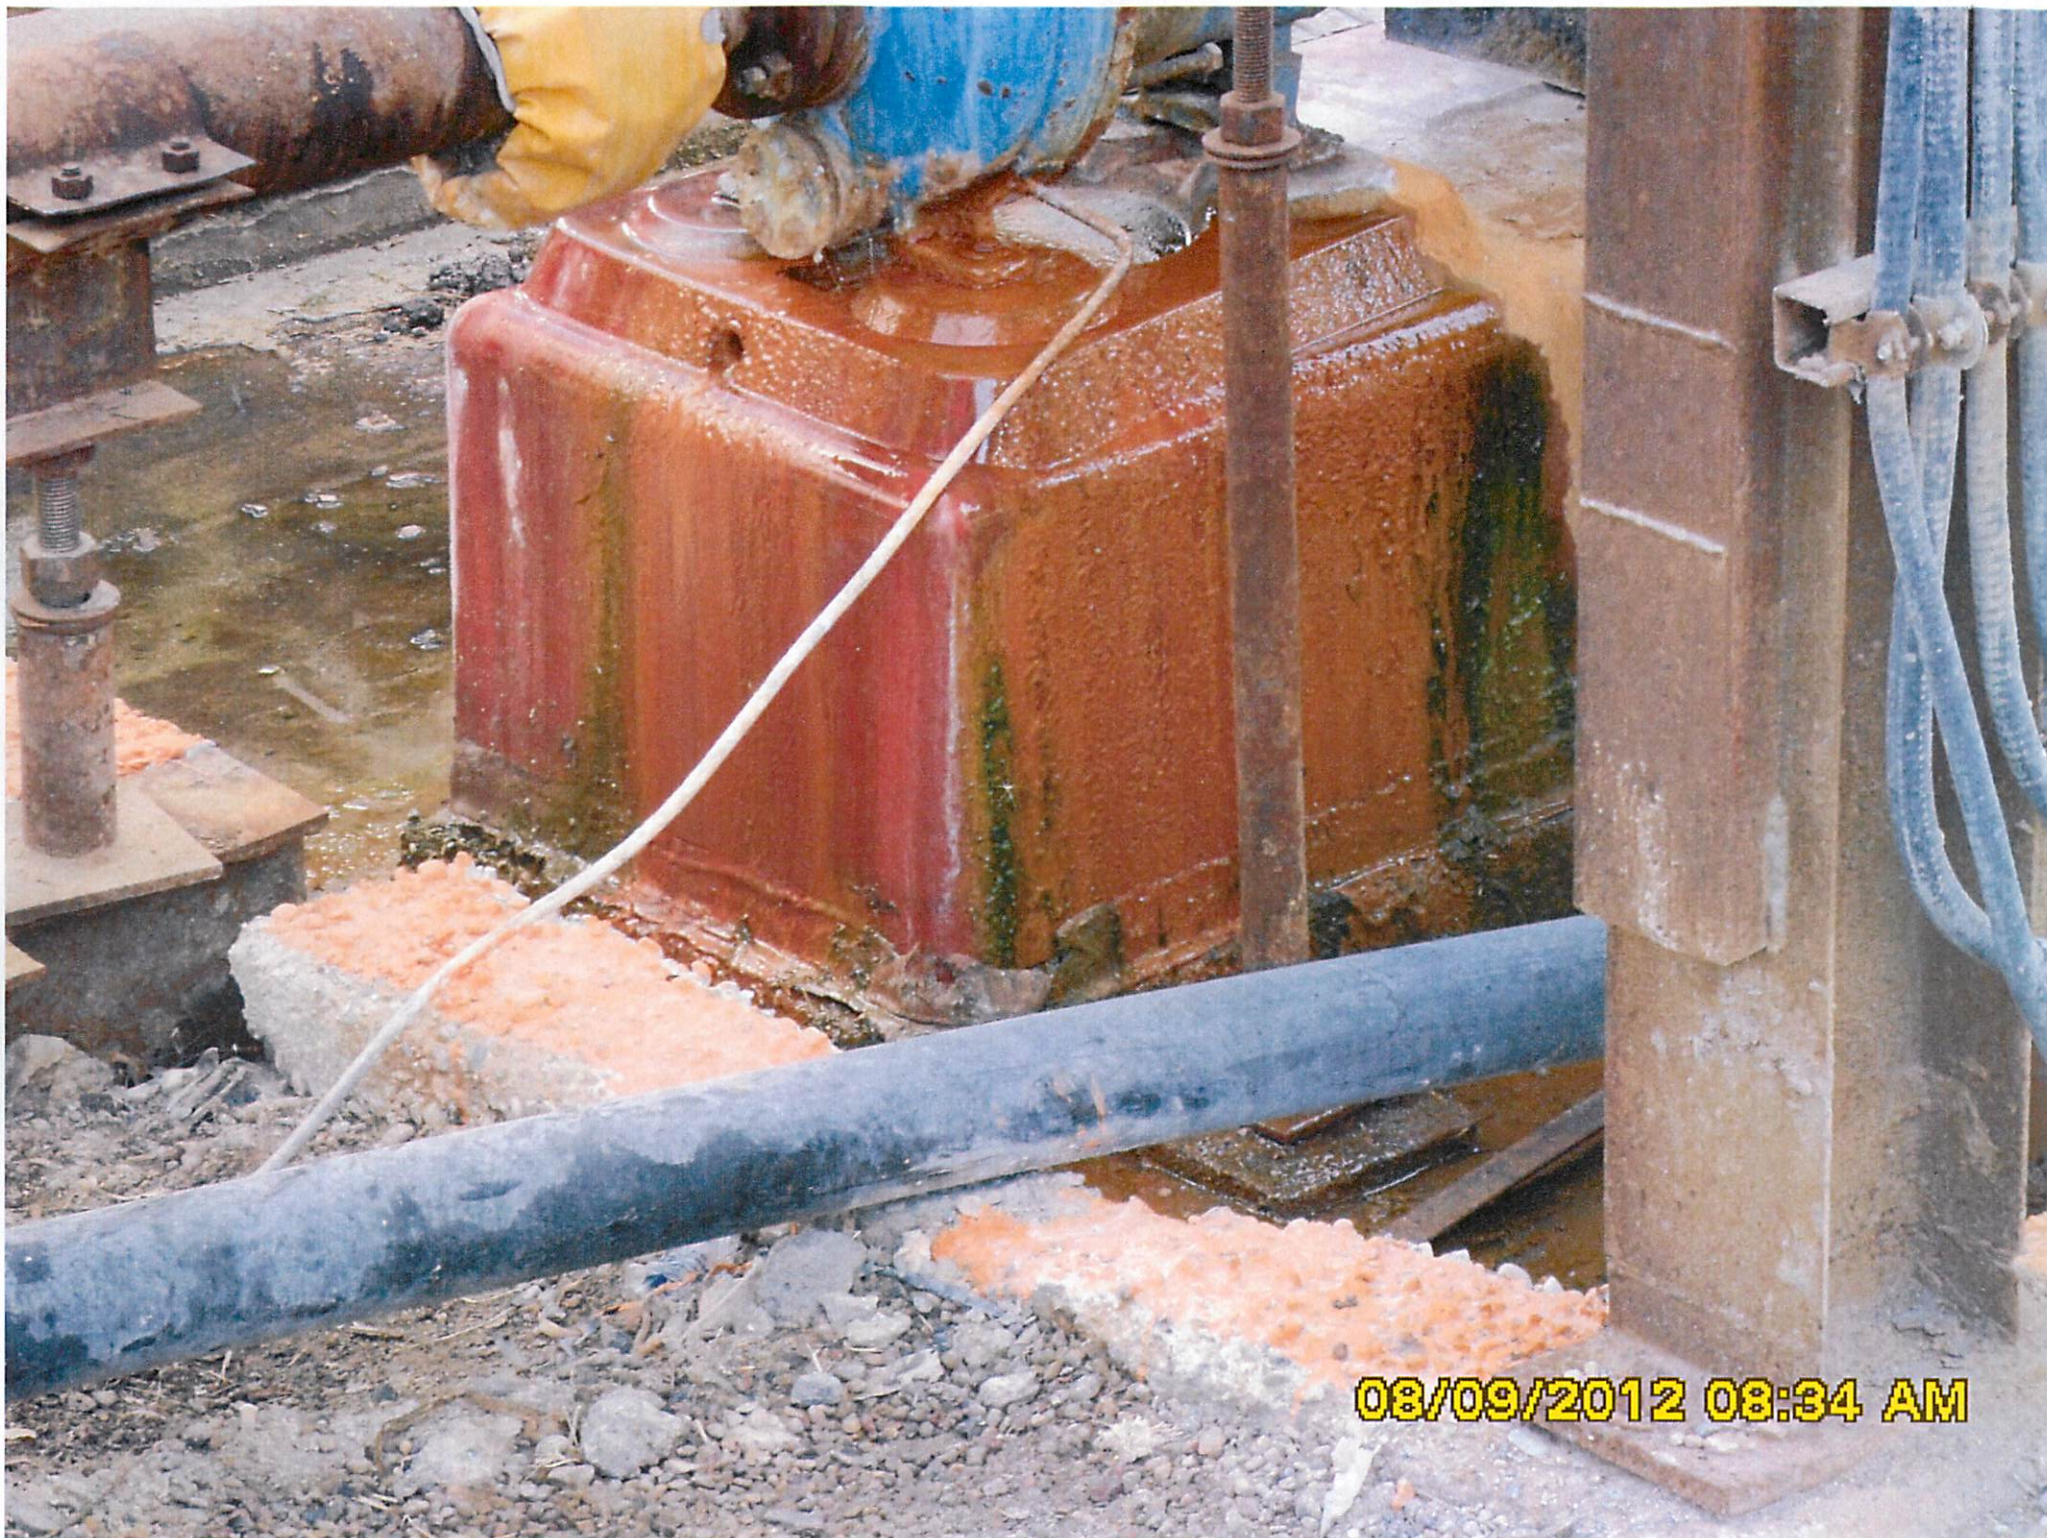
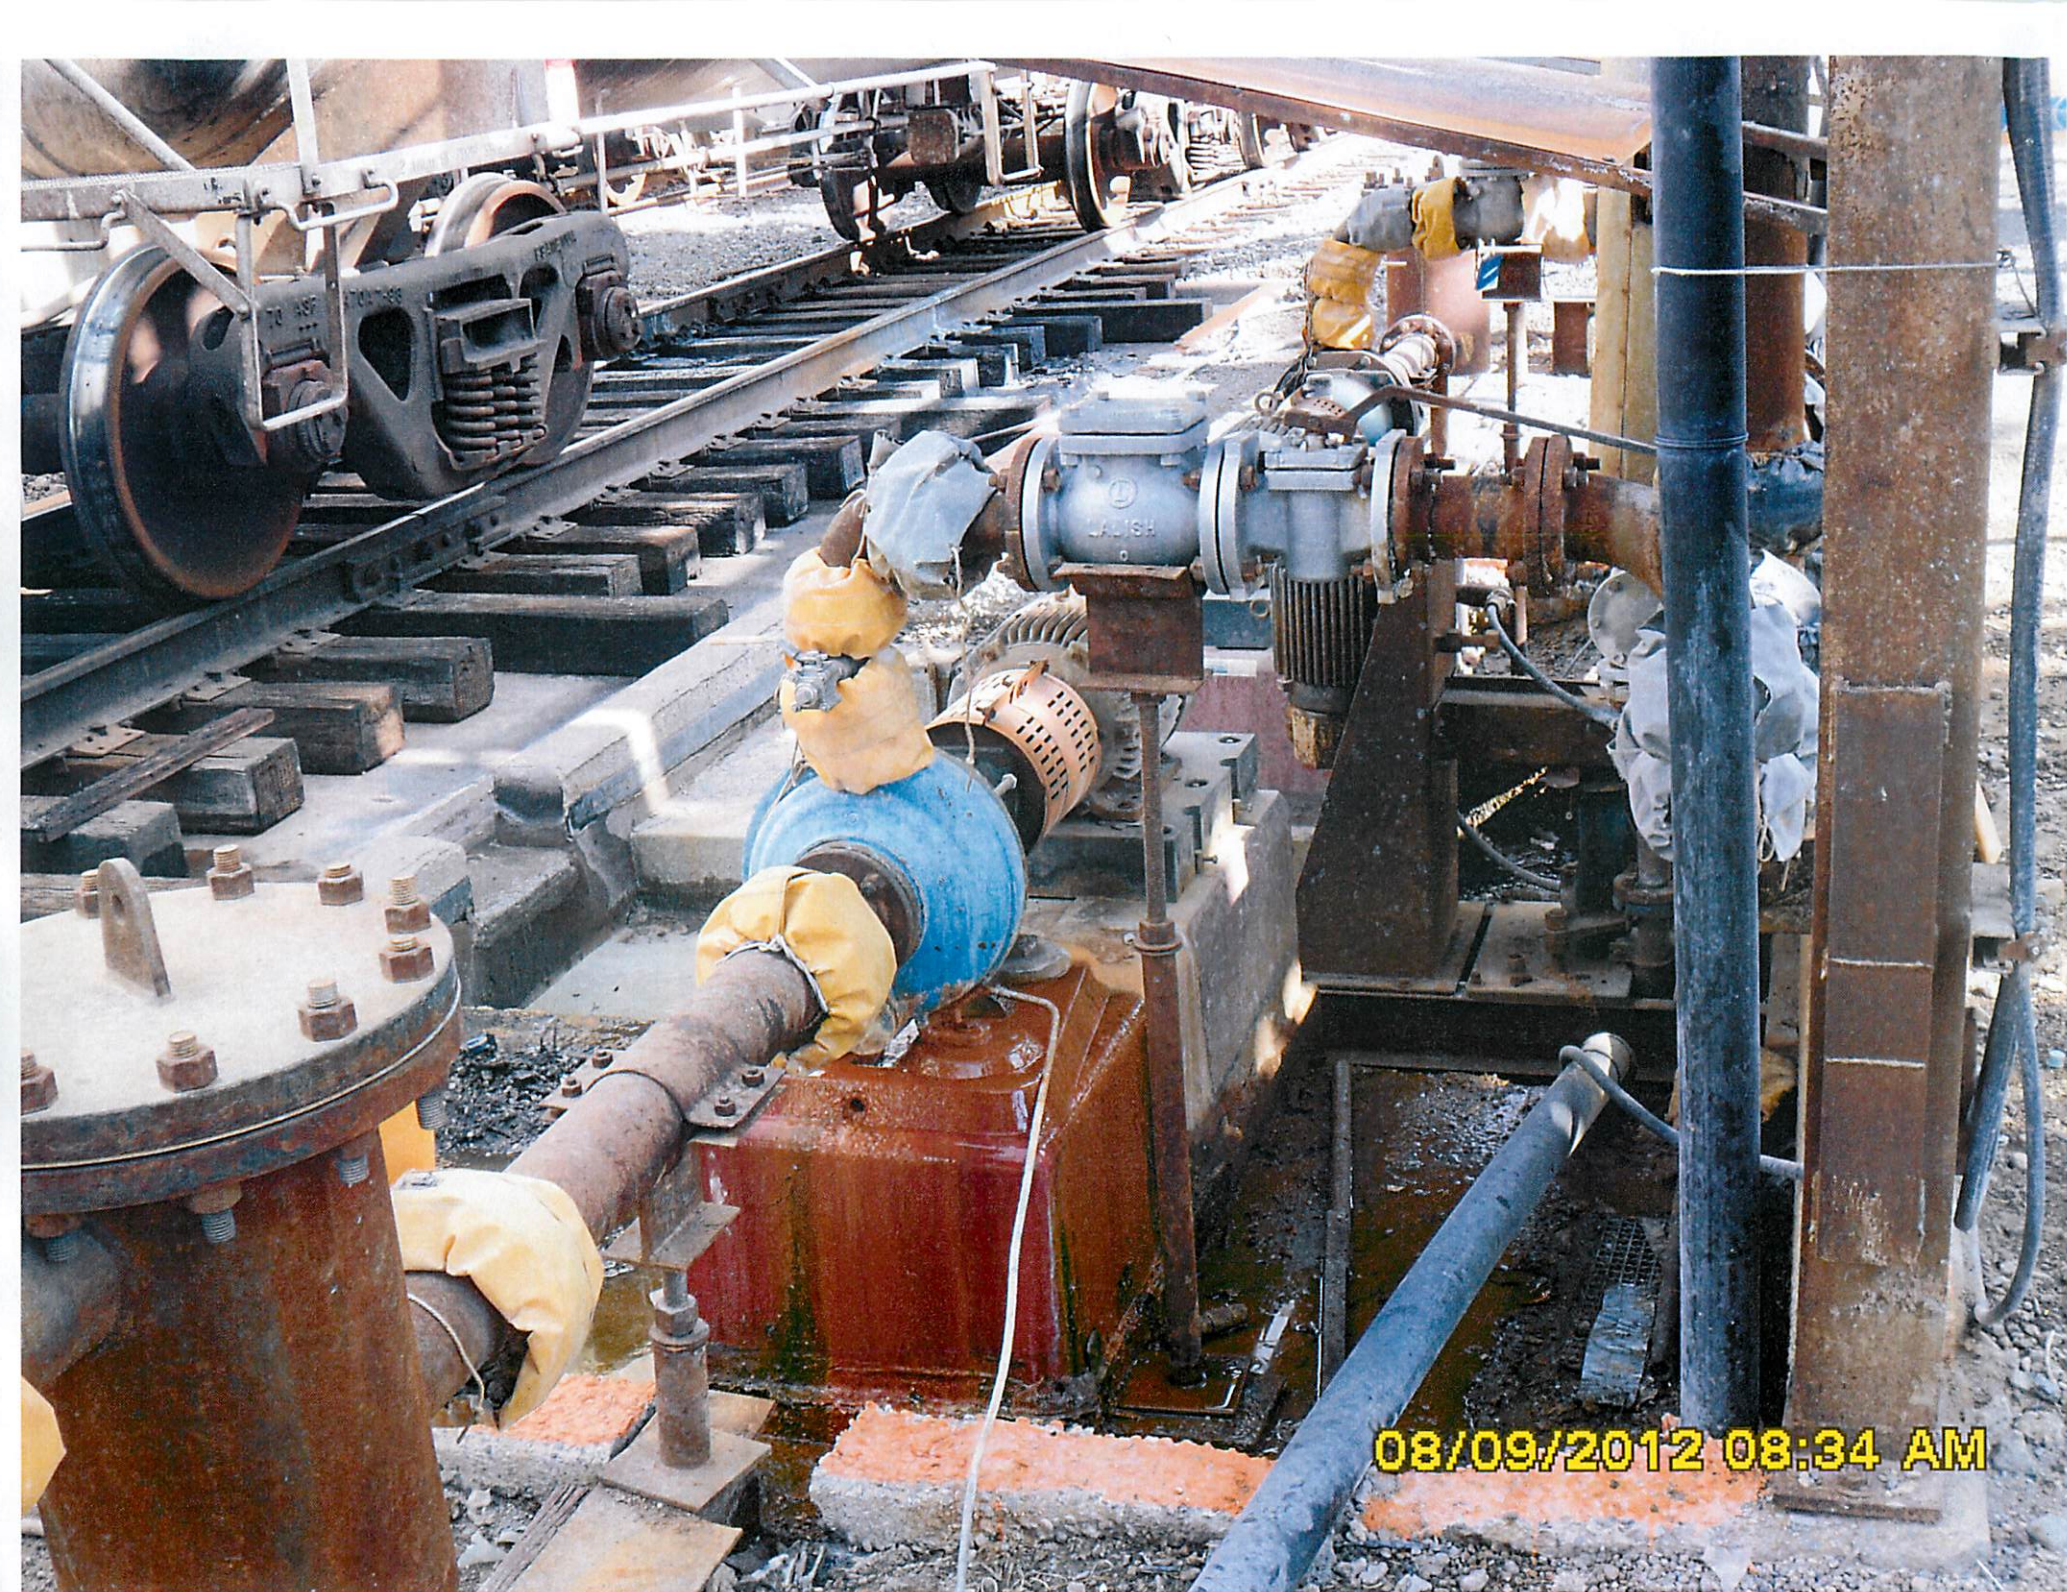
During an EPA inspection in August 2012, a missing portion of concrete in a low-lying section of the SA Railcar Unloading Sump was identified. Fluid was observed dripping from the bottom of the sulfuric acid railcar and directly into the sump. Nu-West personnel were present during EPA's inspection of that sump and also witnessed this condition. However, Nu-West's November 2012 response failed to notice this obvious defect. There may very well be other less visible defects causing releases of waste fluids at the SA Railcar Unloading Sump and at other locations. EPA provided the enclosed photographs of the sulfuric acid railcar unloading sump to Nu-West subsequent to the August 2012 inspection.

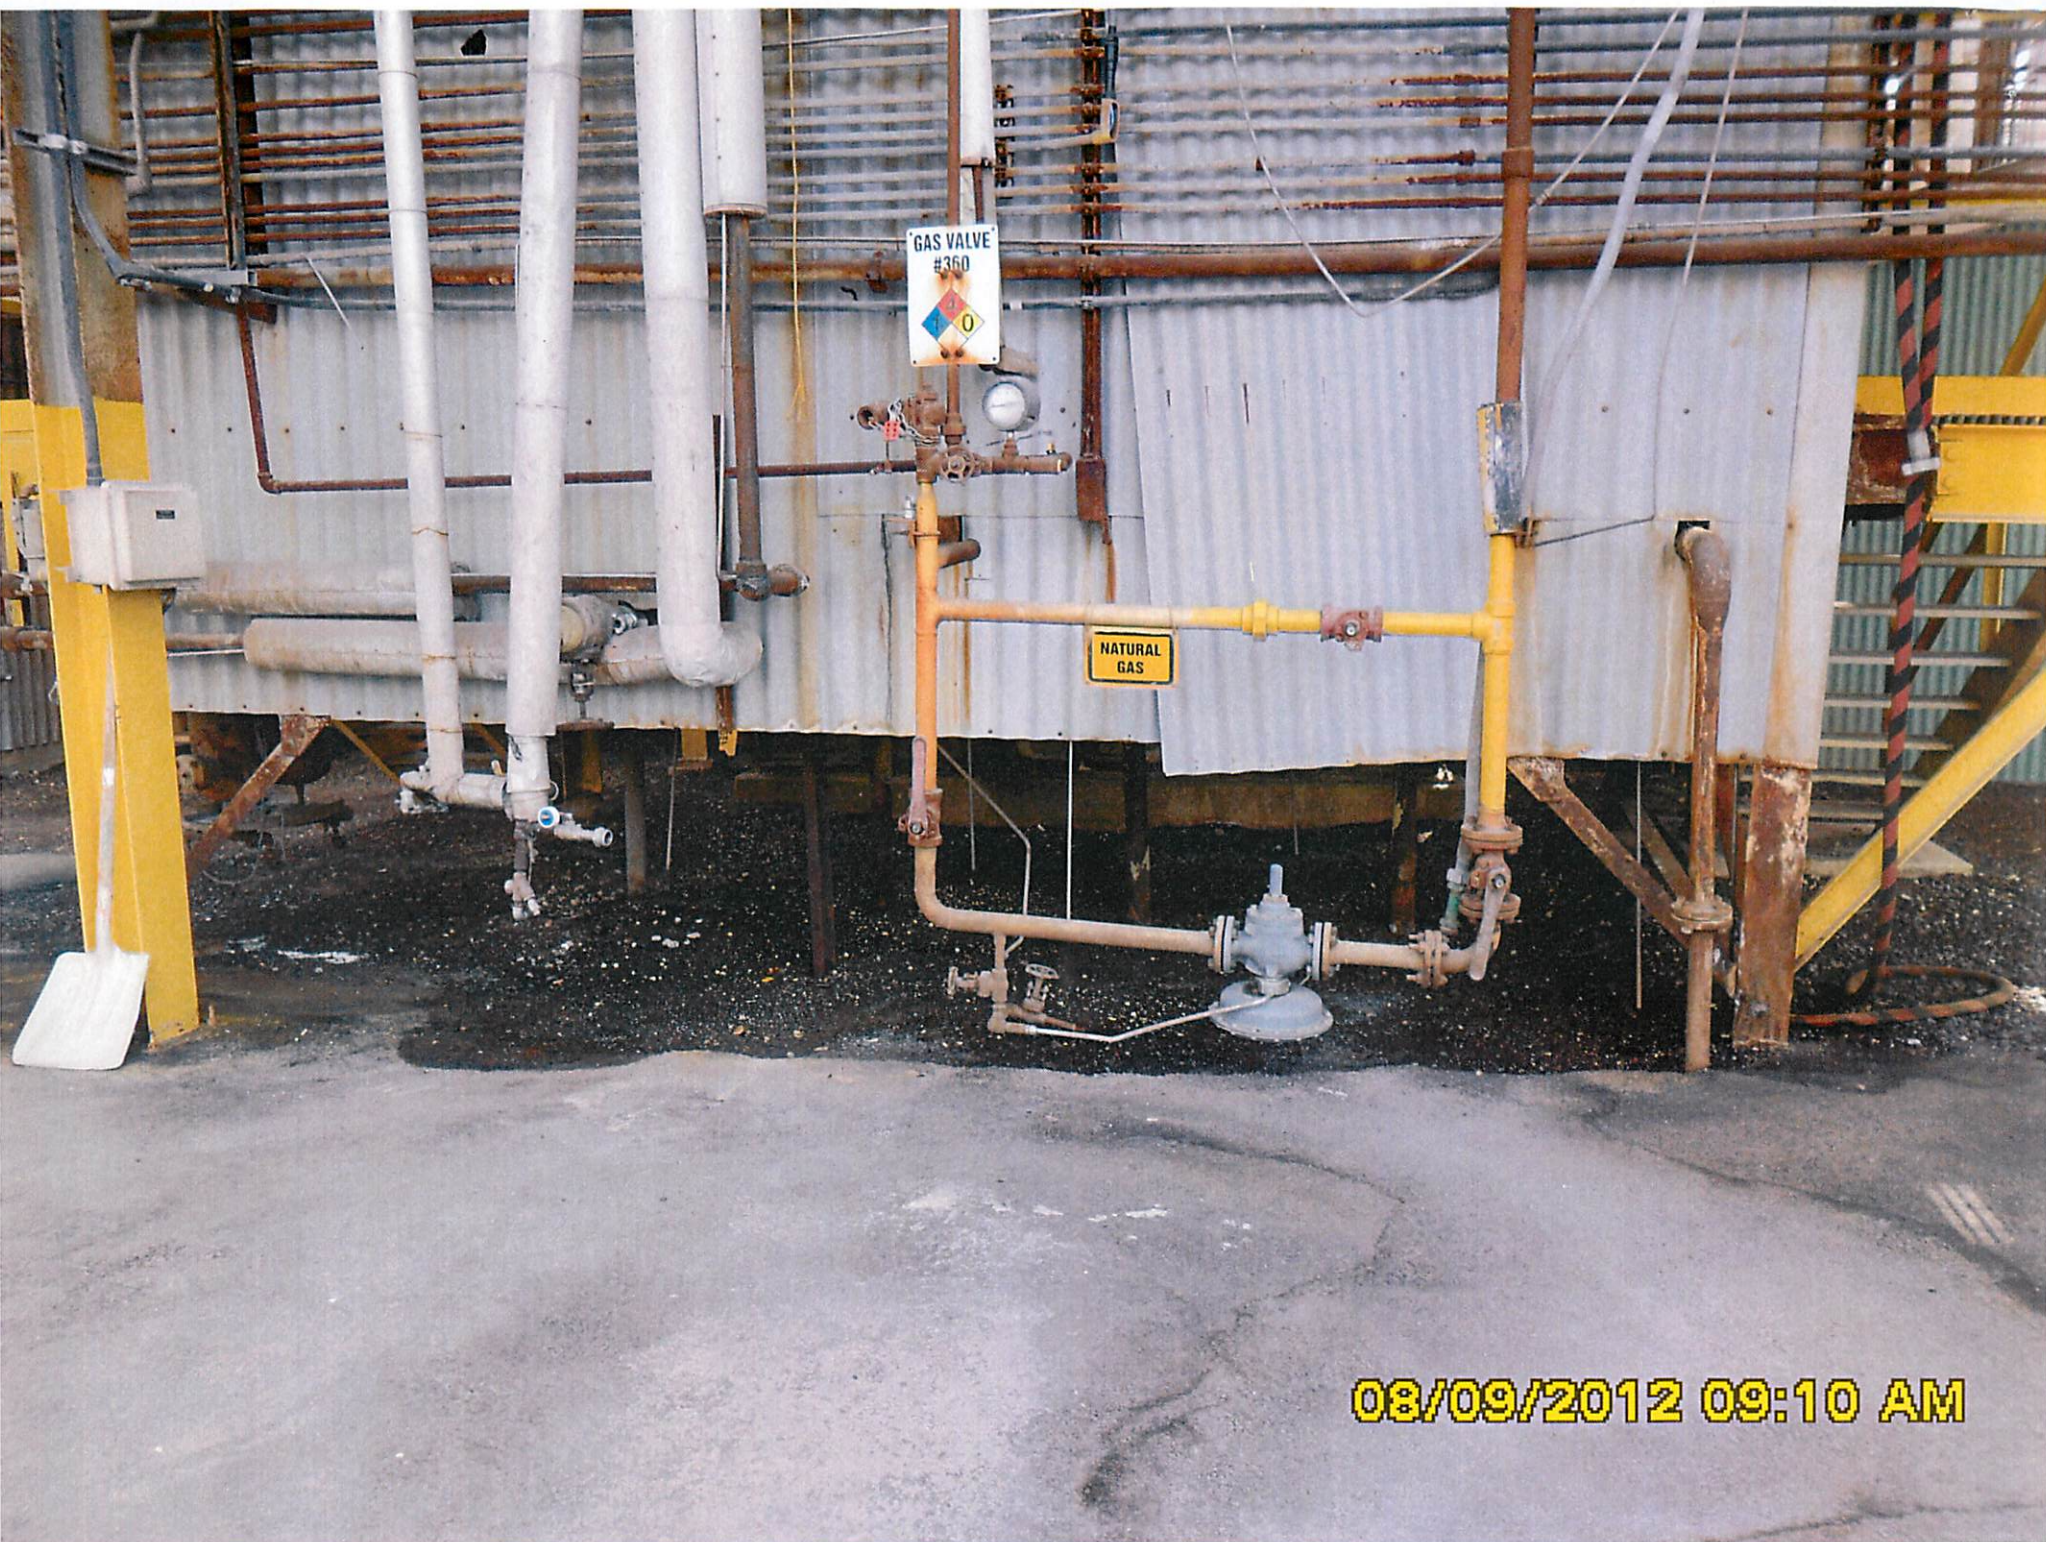
During the same EPA inspection in August 2012, fluid dripping from piping to the ground was observed at the exterior of one of the sulfuric acid plants. EPA provided the enclosed photograph to Nu-West subsequent to the August 2012 inspection. It shows wet soil beneath the piping systems at the sulfuric acid plant.
